FLASH FLOOD EVENTS IN MU CANG CHAI AND MUONG LA ON AUGUST 3, 2017 - CAUSES AND PREVENTION MEASURES

Hoang Minh Tuyen, Luong Huu Dung, Le Tuan Nghia
Viet Nam Institute of Meteorology, Hydrology and Climate Change

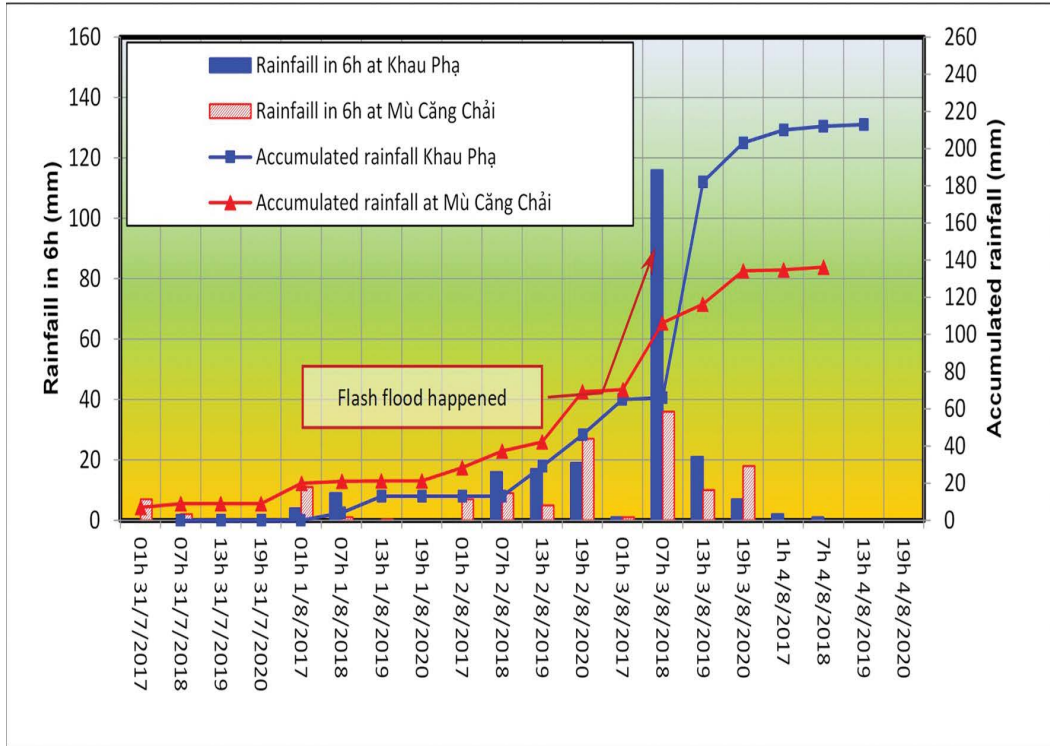
station downstream is only 36 mm, not reflecting the actual situation in the basin. Rainfall measured at some upstream stations from 1h-7h on 3/8/2017 at Khu Pha is 116 mm, at Nga Ba Kim is 100 mm (Figure 3). From the landslide trail of the steep mountain slopes showed that in the upstream, extremely heavy rain could range from 100-200 mm in 6 hours.

Figure 3. Rainfall at Mu Cang Chai and Khu Pha Gauges

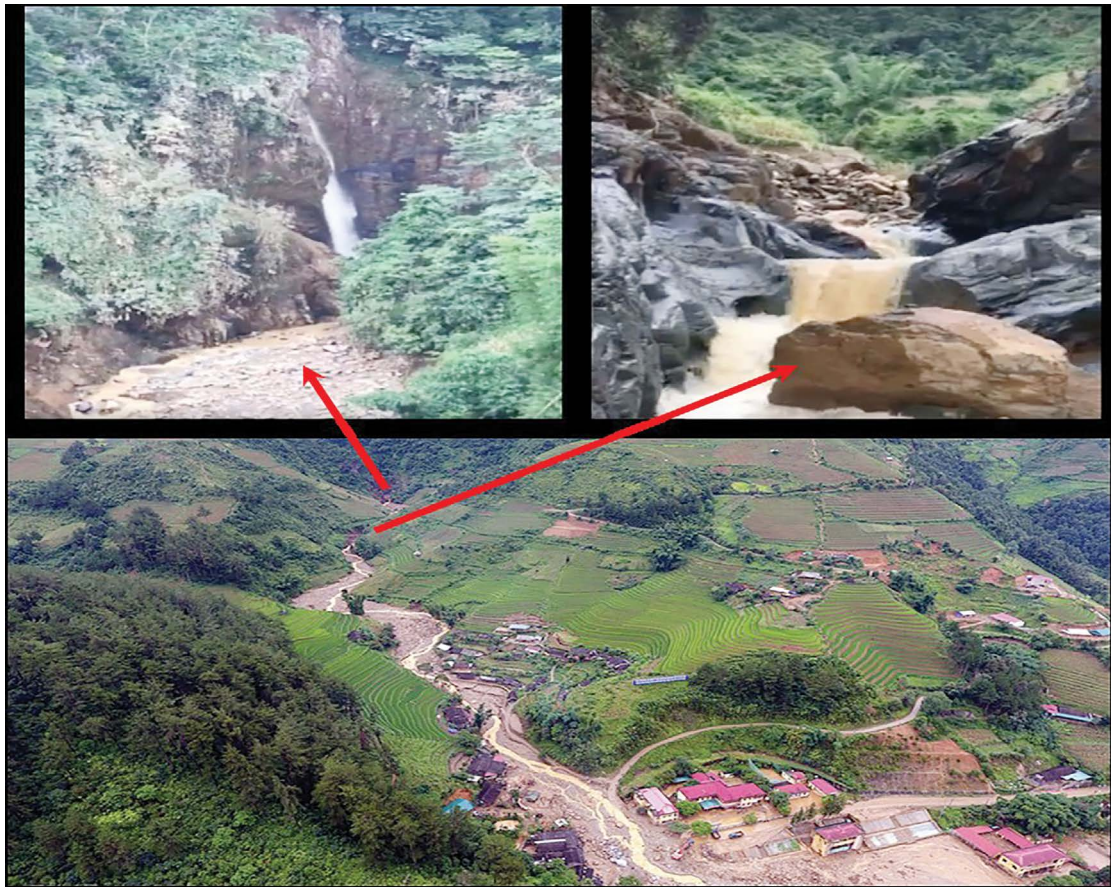
From the location where the Kim Noi stream flows into Nam Kim stream to the upstream about 600 m, the cross-section of the stream narrowed about 50%, the two sides of the stream are vertical cliffs, the width is only about 7-8 m. There is a deep pit at this location. From here, the release cap began to develop, streams gradually expanded. This is a congestion of the flow, trees, and rocks that make up temporary dams, forming natural water tanks for rainwater storage. When the water was big enough to break the dam, it poured down from the top abruptly,

carrying many of the rocks and soil of the ancient streams which were loose due to rain for many days, to the downstream, wiping out the houses and plants along the flow. The damaged stream is only about 500-600 m (Figure 4).

Generally, in small watersheds (<5 km²), such rainfall amount rarely generates huge amounts of water down to downstream in a short time and causing flash floods. The actual reasons are the local heavy rain and narrow streams that build up temporal reservoirs in the upstream. The reservoirs with weak dams become “water balls” and easily explode. If an upstream dam breaks, the downstream ones will consecutively break and throw huge water amount to downstream like dominos.

Figure 4. Photos of Kim Noi stream after flash flood

- Expand flood drainage at downstream of Kim Noi river, especially the stadium and ethnic intern school has built and blocked the floodway;

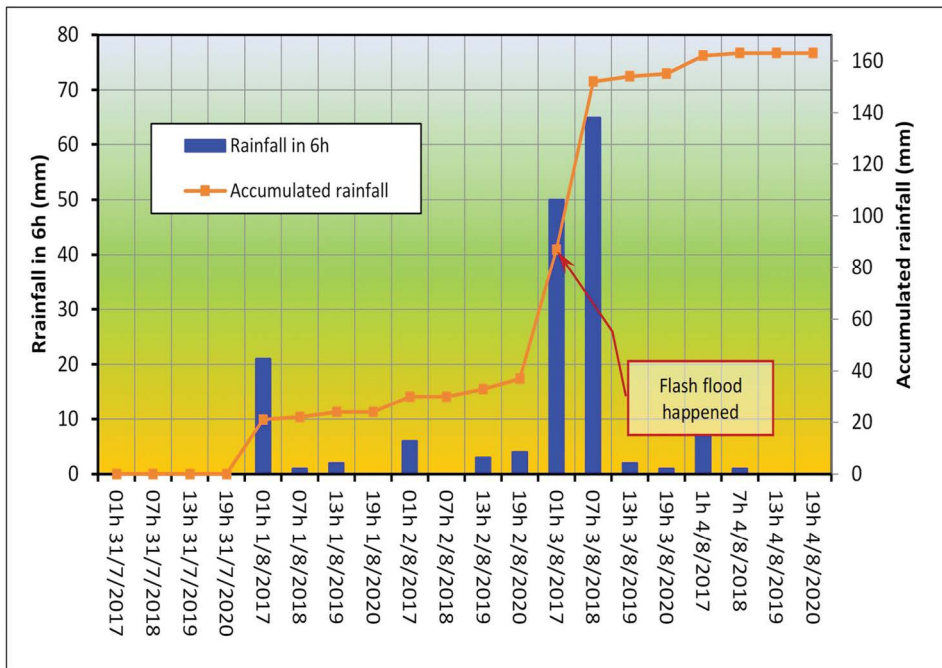
Comparing to Kim Noi stream, Nam La watershed is approximate 24 times larger and the stream is 20 times longer. The flash flood in Nam La, thus, is more extreme. The observed data of 12-hour rainfall (19:00 to 7:00 3/8/2017) at Muong La station is 115 mm (Figure 5), at Khau Pha is 116 mm and at Nga Ba Kim stations near Kim Noi watershed is 100 mm. This high-intensity rainfall occurred in large basin area combining with a steep watershed accumulated to a huge amount of water that is potential for flash floods. Along the Nam Pam stream to It Ong direction, there are three sites with stream cross sections shrinks from 25-80% (Figure 2). The detailed description is given as follows.

Figure 5. Rainfall data at Mu Cang Chai and Khau Pha Gauges

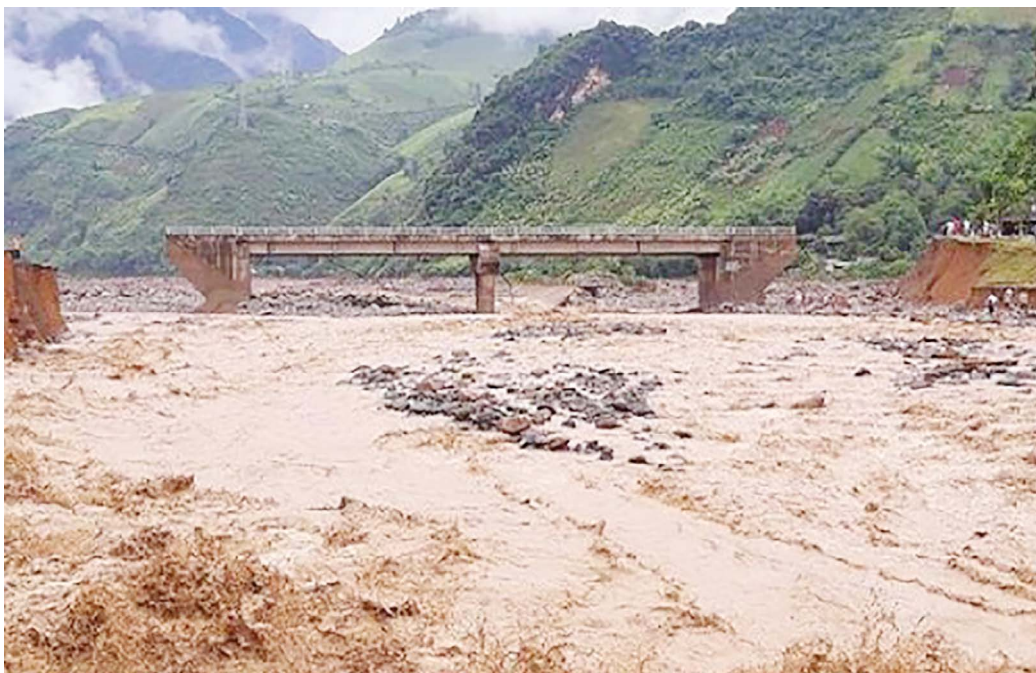
- The 3rd place is Nam Pam Bridge. Road to the bridge, piers and abutments of the bridge narrowed the natural river cross-section by 55-60%. The flood flow of Nam Pam before passing over Nam Pam Bridge was supplemented with a large amount of water from the Nam Toong

stream on the right. The accumulated flood of 2 tributaries met the narrow area Nam Pam

bridge and broke down the abutment bridge to the downstream (Figure 6).

Figure 6. Nam Pam bridge destroyed by flash flood

dams caused a dam break effect from upstream to downstream dams, creating flash flood over 10km of streams. Flood flew to It Ong to meet Nam Pam bridge, with huge amounts of water poured into congestion, causing overflow, flooding and breaking bridges to drain water to Da River.

- Expand cross-section at clogging points, especially in Nam Pam river at Na Loc village and Nam Pam bridge built across the stream in It Ong town, Muong La district;

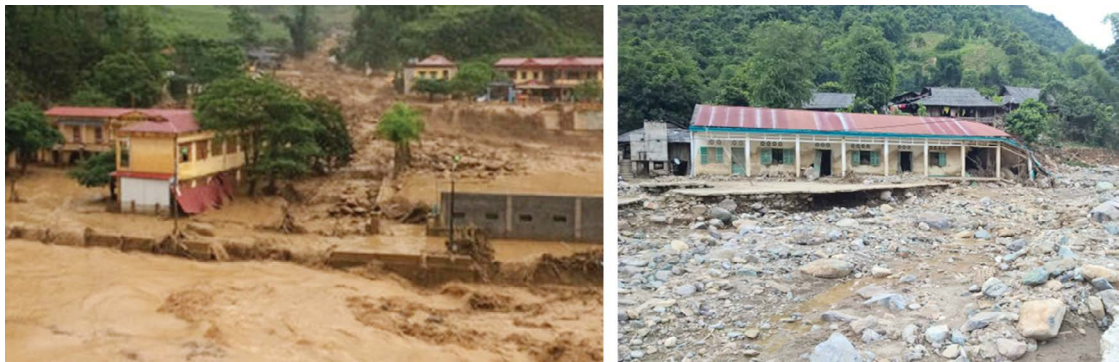
In summary, two flash floods that occurred in the early morning of 3/8/2017 in Mu Cang Chai and Muong La are caused by locally heavy rainfall combined with water-clogging phenomenon. They are the typical floods that often occur in mountainous area with disintegration terrain and high probability of landslide.

Figure 7. The picture of Kim Noi and Nam Pan stream after flash flood
