FLASH FLOOD EVENTS IN MU CANG CHAI AND MUONG LA ON AUGUST 3, 2017 - CAUSES AND PREVENTION MEASURES

Hoang Minh Tuyen, Luong Huu Dung, Le Tuan Nghia
Viet Nam Institute of Meteorology, Hydrology and Climate Change

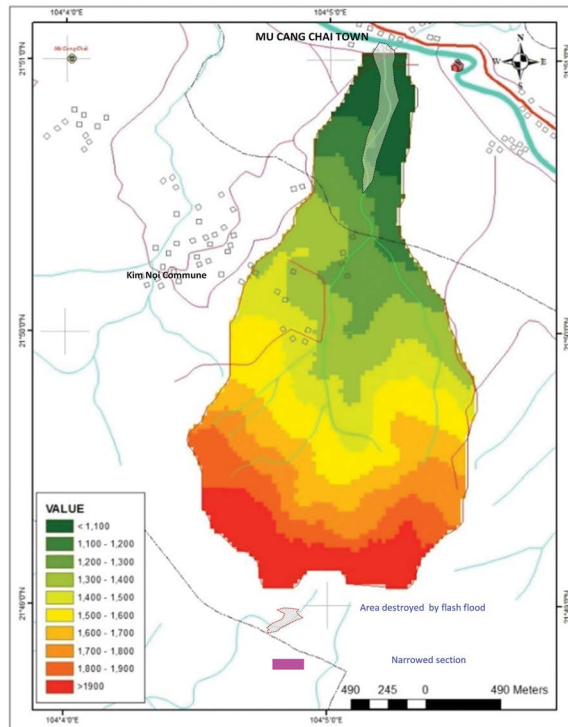
Figure 1. Kim Noi watershed

outlet to upstream with mild slope <10% and gradually expanding streambed. In this part, the footprint of the ancient stream is exposed to the loose rocks that are the remnants of flash floods in the past (Figure 1). Local people now still live in this area. The upstream part is steeper with a slope of over 17% and narrow streams flowing between two rocky cliffs. Stream cross-sections in this part are around 8 m corresponding to the highest flood mark. In the basin, the primeval forest is almost disappearing, and crop fields are mainly maize and rice.

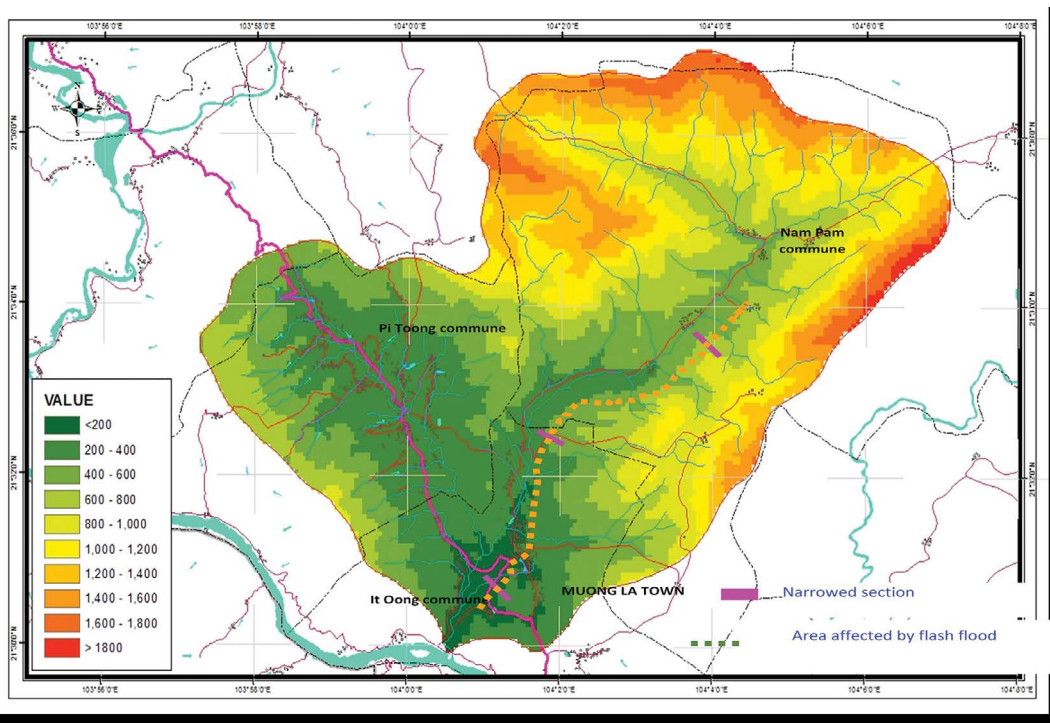
Figure 2. Nam Pam watershed

Nam Pam is a large stream, flowing directly into Da River immediately after Son La hydro power plant. Nam Pam basin area is about 110 km², the average slope of the basin is about 40%. The mainstream is nearly 13 km long, stream slopes about 10.5%. The Pi Toong stream is the largest tributary to the right of the Nam Pam stream with a basin area of 34.6 km² (accounting for one-third of the whole basin area). However, this basin has fairly flat terrain, the average slope of the basin is 30% and stream slope is only about 4%. Therefore, the potential for flash floods in the Pi Toong tributary is not high. In fact, the flash floods on 3/8/2017 and 14/8/2017 indicated that flash floods only occur along the Nam Pam stream (Figure 2).
